NSWC TR 79-259

**PRODUCTION AND ASSESSMENT OF DAMAGED
HIGH ENERGY PROPELLANT SAMPLES**

BY WAYNE L. ELBAN

8 MAY 1980

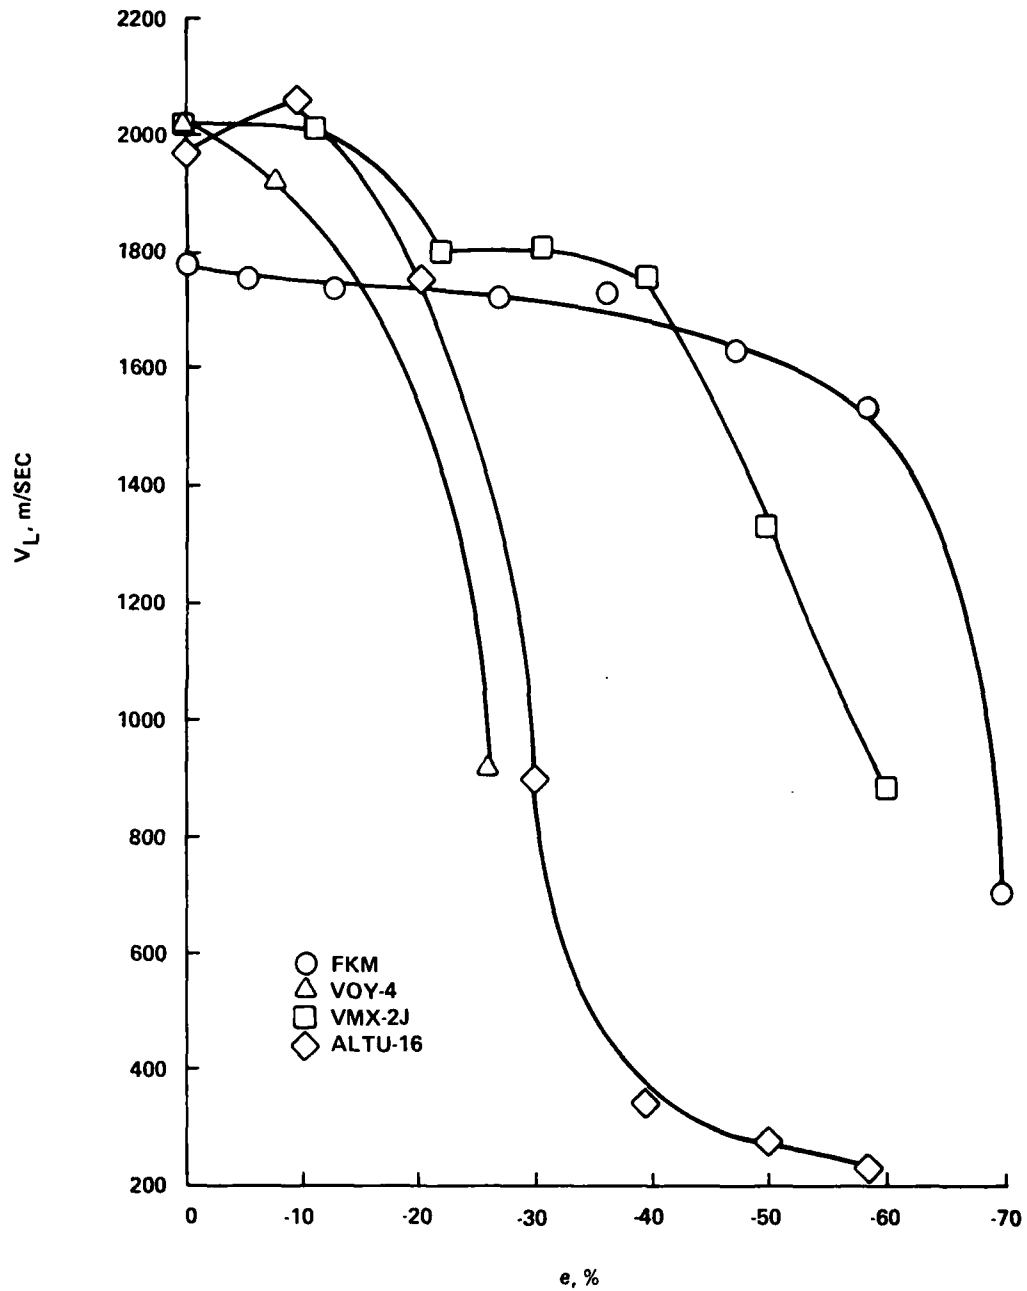
The results¹¹ for straining FKM, VOY-4, VMX-2J, and ALTU-16 in compression have been reported previously, and only a summary will be given, including some of the more interesting results. In general, the samples that had been mechanically deformed at the low strain rate used in this work did not exhibit extensive damage. Crack densities were found to be very low. The propellant exhibiting the most visible damage was FKM, and the cylinders subjected to the three highest strains appear in Figure 2. For this particular material, there were numerous cracks (see samples strained to -58.5 and -69.8%) at the casting grain boundaries. Very little cracking was visible in the cylinders of the remaining compositions. Longitudinal velocity measurements¹¹ one hour after compressing to various strain levels are given in Figure 3 for the various propellants. In each instance, there was a decrease in sound speed with increasing applied strain, although the rate of decrease differed markedly. Reductions in sound speed, by as much as 88%, were obtained for ALTU-16.

FIGURE 3 LONGITUDINAL VELOCITY ONE HOUR AFTER COMPRESSING VERSUS APPLIED ENGINEERING COMPRESSIVE STRAIN FOR PROPELLANT SAMPLES (NOMINAL 40 mm DIA x 13 mm HIGH) (TAKEN FROM REFERENCE II).
